# THE HAMPTONS

Soil Validation Report

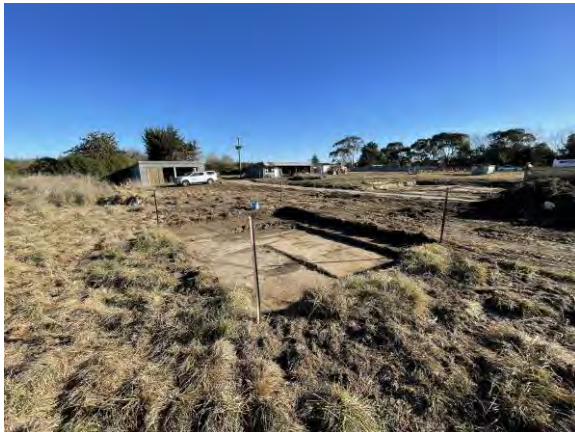
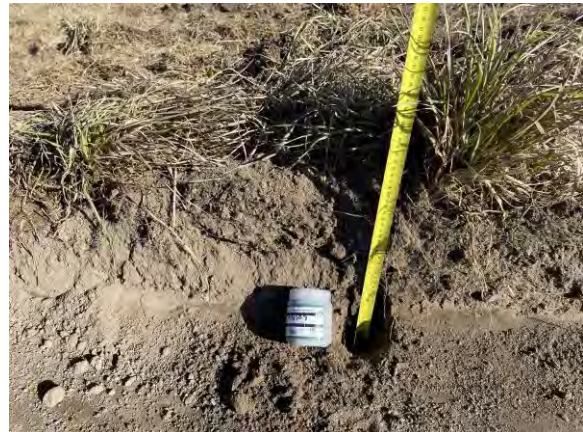
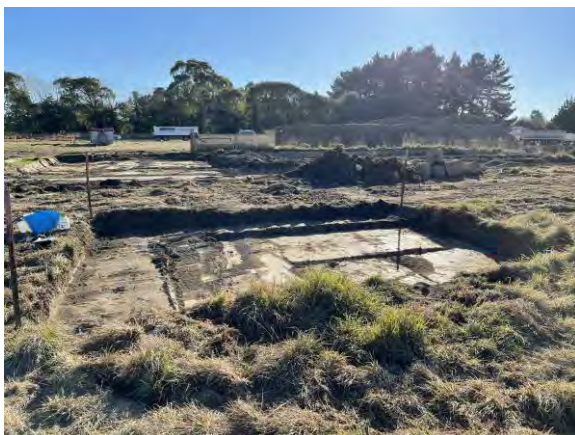
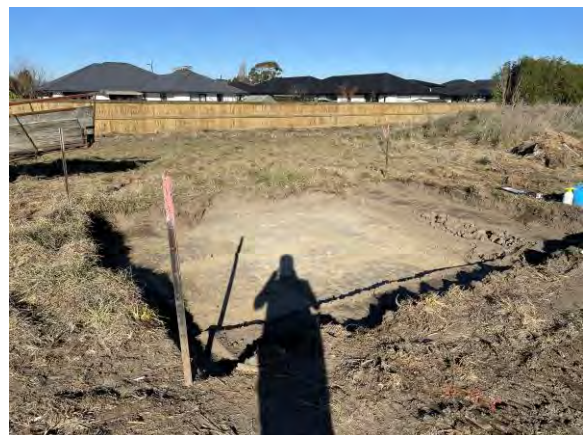
**Figure 1: Area 1 Photographs**

The soil in Area 1 was free from any visual or olfactory indicators of waste. The area was excavated in a 4.5 x 4.5 m grid down to 0.3 m in depth. Remedial area and sample locations included in Figure 2 appended.

Photo 1: 7 June 2024 Area 1 looking southwest

Photo 2: 7 June 2024 Area 1 300 mm deep side wall

Photo 3: 7 June 2024 Area 1 looking west

Photo 4: 7 June 2024 Area 1 looking east

An initial five soil samples were collected from Area 1, one from the base and one each from each wall with analysis for heavy metals. Three of the initial soil samples were reported above the site-specific regional background criteria for lead and / or zinc. It was recommended to undertake an additional scrape off the north, south, and western wall. The three additional validation soil samples reported concentrations below the background criteria and below the relevant NES land use criteria. No further remediation was required.

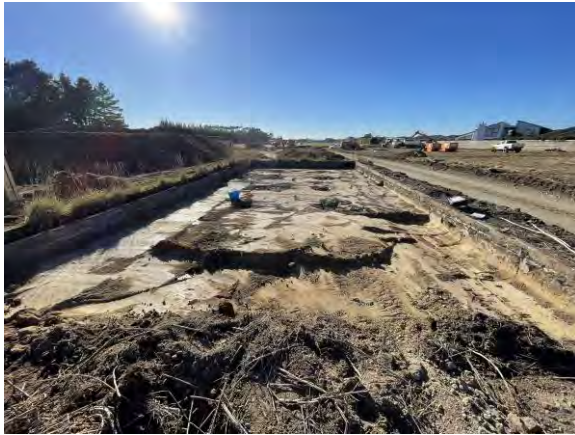
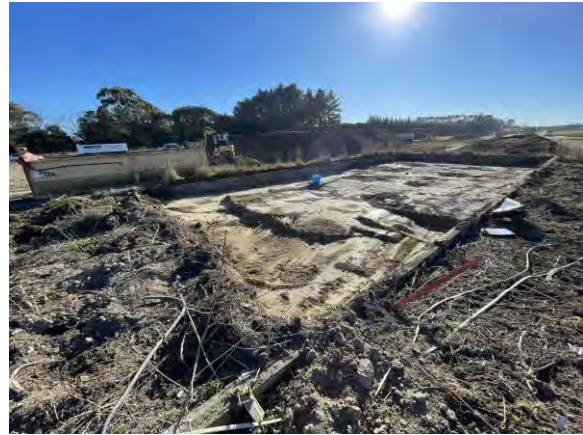
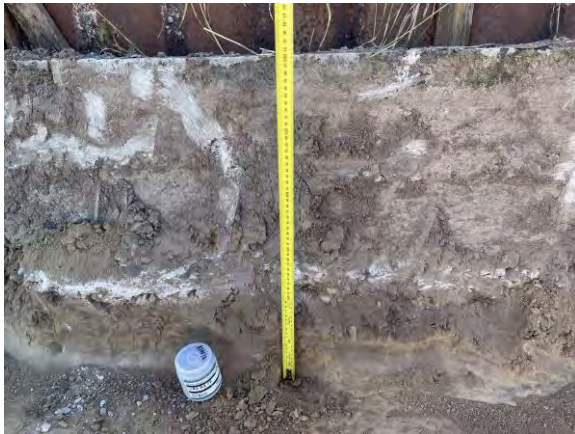
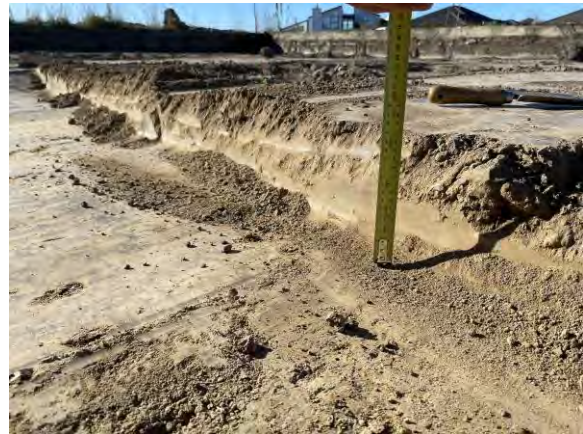
**Figure 2: Area 2 Photographs**

The soil in Area 1 was free from any visual or olfactory indicators of waste. The area was excavated in a 16 x 10 m grid down to 0.2 to 0.5 m in depth. Please note that the majority of the grid was excavated to 0.2 m depth and then additional excavations undertaken after initial samples were completed down to 0.5 m depth. Remedial area and sample locations are included in Figure 3 appended.

Photo 5: 7 June 2024 Area 2 looking north

Photo 6: 7 June 2024 Area 2 looking northwest

Photo 7: 7 June 2024 Area 2 western side wall – 500 mm

Photo 8: 7 June 2024 Area 2 eastern side wall – 200 mm

An initial 11 soil samples were collected from around Area 2 in the former glasshouse. Five samples were collected from the base of the remedial area and six from the excavation walls with analysis for heavy metals. One sample, A2 VS10, reported concentrations of arsenic above the NES residential land use criteria. Three samples were also reported above the background concentrations for arsenic. It was recommended to undertake further remediation of the three areas around these samples. Four additional samples were collected after the second remedial excavation was completed. All four samples were reported below the applicable NES residential land use criteria and below the background concentrations. No further remediation was required.

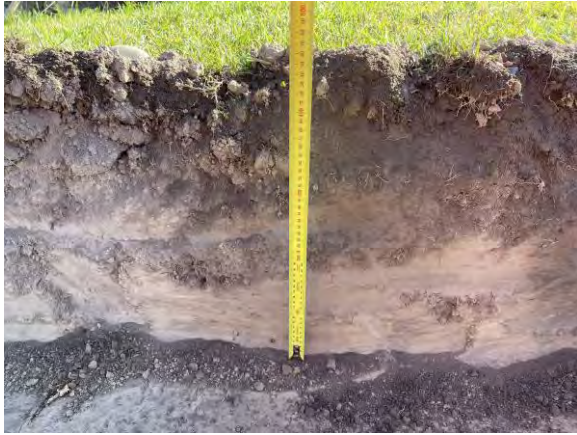
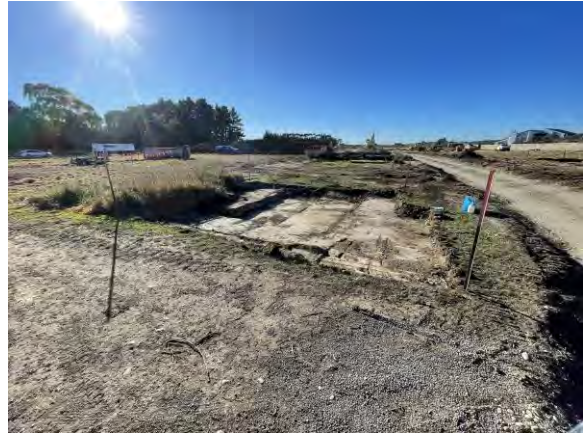
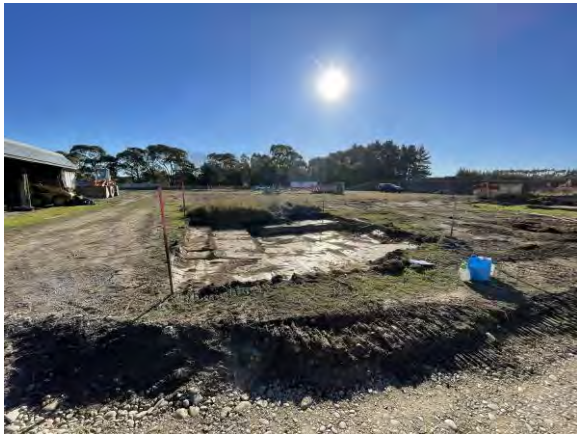
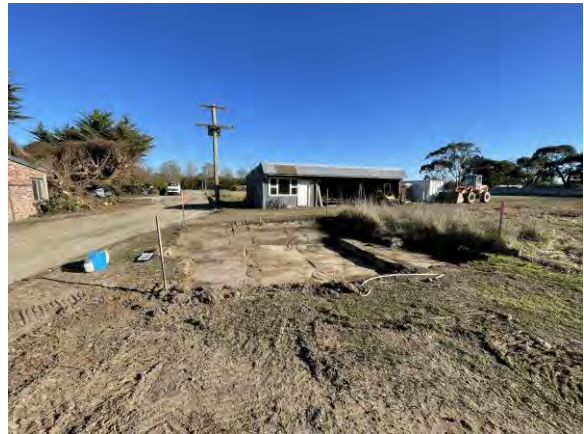
**Figure 3: Area 3 Photographs**

The soil in Area 1 was free from any visual or olfactory indicators of waste. The area was excavated in a 6 x 5 m grid down to 0.3 m in depth. Remedial area and sample locations are included in Figure 4 appended.

Photo 9: 7 June 2024 Area 3 side wall 350 mm excavation

Photo 10: 7 June 2024 Area 3 looking northwest

Photo 11: 7 June 2024 Area 3 looking west

Photo 12: 7 June 2024 Area 3 looking south

An initial five samples were collected from across remedial Area 3, former animal pen area with analysis for lead only. Samples were collected from the base of the grid and one from each wall of the excavation. All five samples were reported below the applicable NES land use criteria. Four samples were reported above the background values for the site. It was recommended that additional excavations were completed on the walls of the grid to try and remove the remaining contamination. An additional three samples were collected after additional remedial excavations. Two of the samples were still reported above the background values, however at much lower concentrations, 60 mg/kg and 44 mg/kg with the background value at 40.96 mg/kg. No further remediation is required.

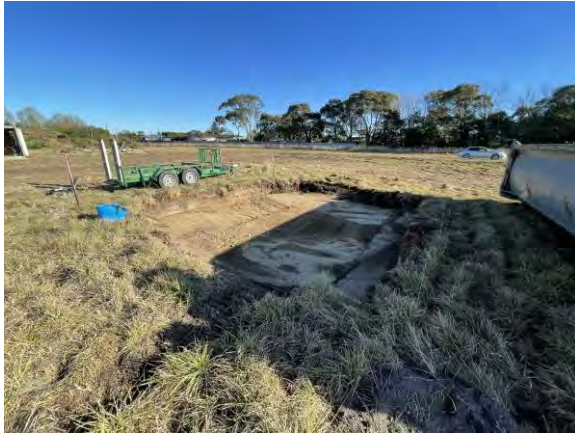
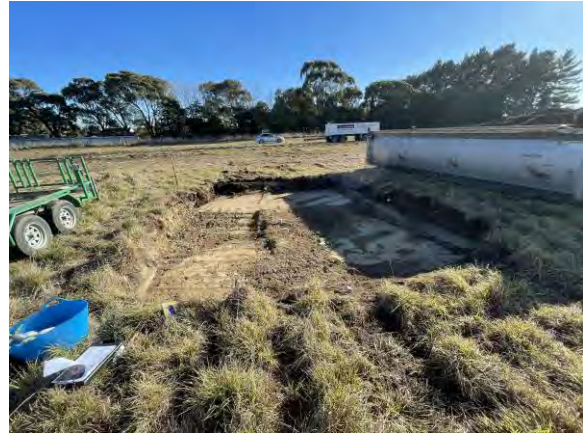
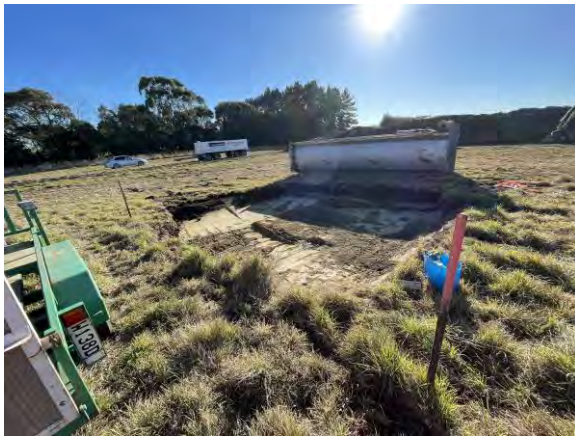
**Figure 4: Area 4 Photographs**

The soil in Area 1 was free from any visual or olfactory indicators of waste. The area was excavated in a 7.5 x 7.5 m grid down to 0.3 m in depth. Remedial area and sample locations are included in Figure 5 appended.

Photo 13: 7 June 2024 Area 4 looking southwest

Photo 14: 7 June 2024 Area 4 looking west

Photo 15: 7 June 2024 Area 4 looking northwest

The remedial contractor initially only undertook a 200 mm remedial excavation under the burn pile. Two initial soil samples were collected after the first excavation with analysis for heavy metals. Both samples reported arsenic above the NES residential land use criteria. The two initial samples were also reported at much lower concentrations, it was determined that the remaining soil was suitable for disposal to Frews Hororata. An additional excavation was undertaken across the entire remedial area with an additional 100 mm excavation. Five additional soil samples were collected, one from the base and one each from each wall. All five samples were reported below the NES residential land use criteria and below the site-specific regional background levels. No further remediation was required.

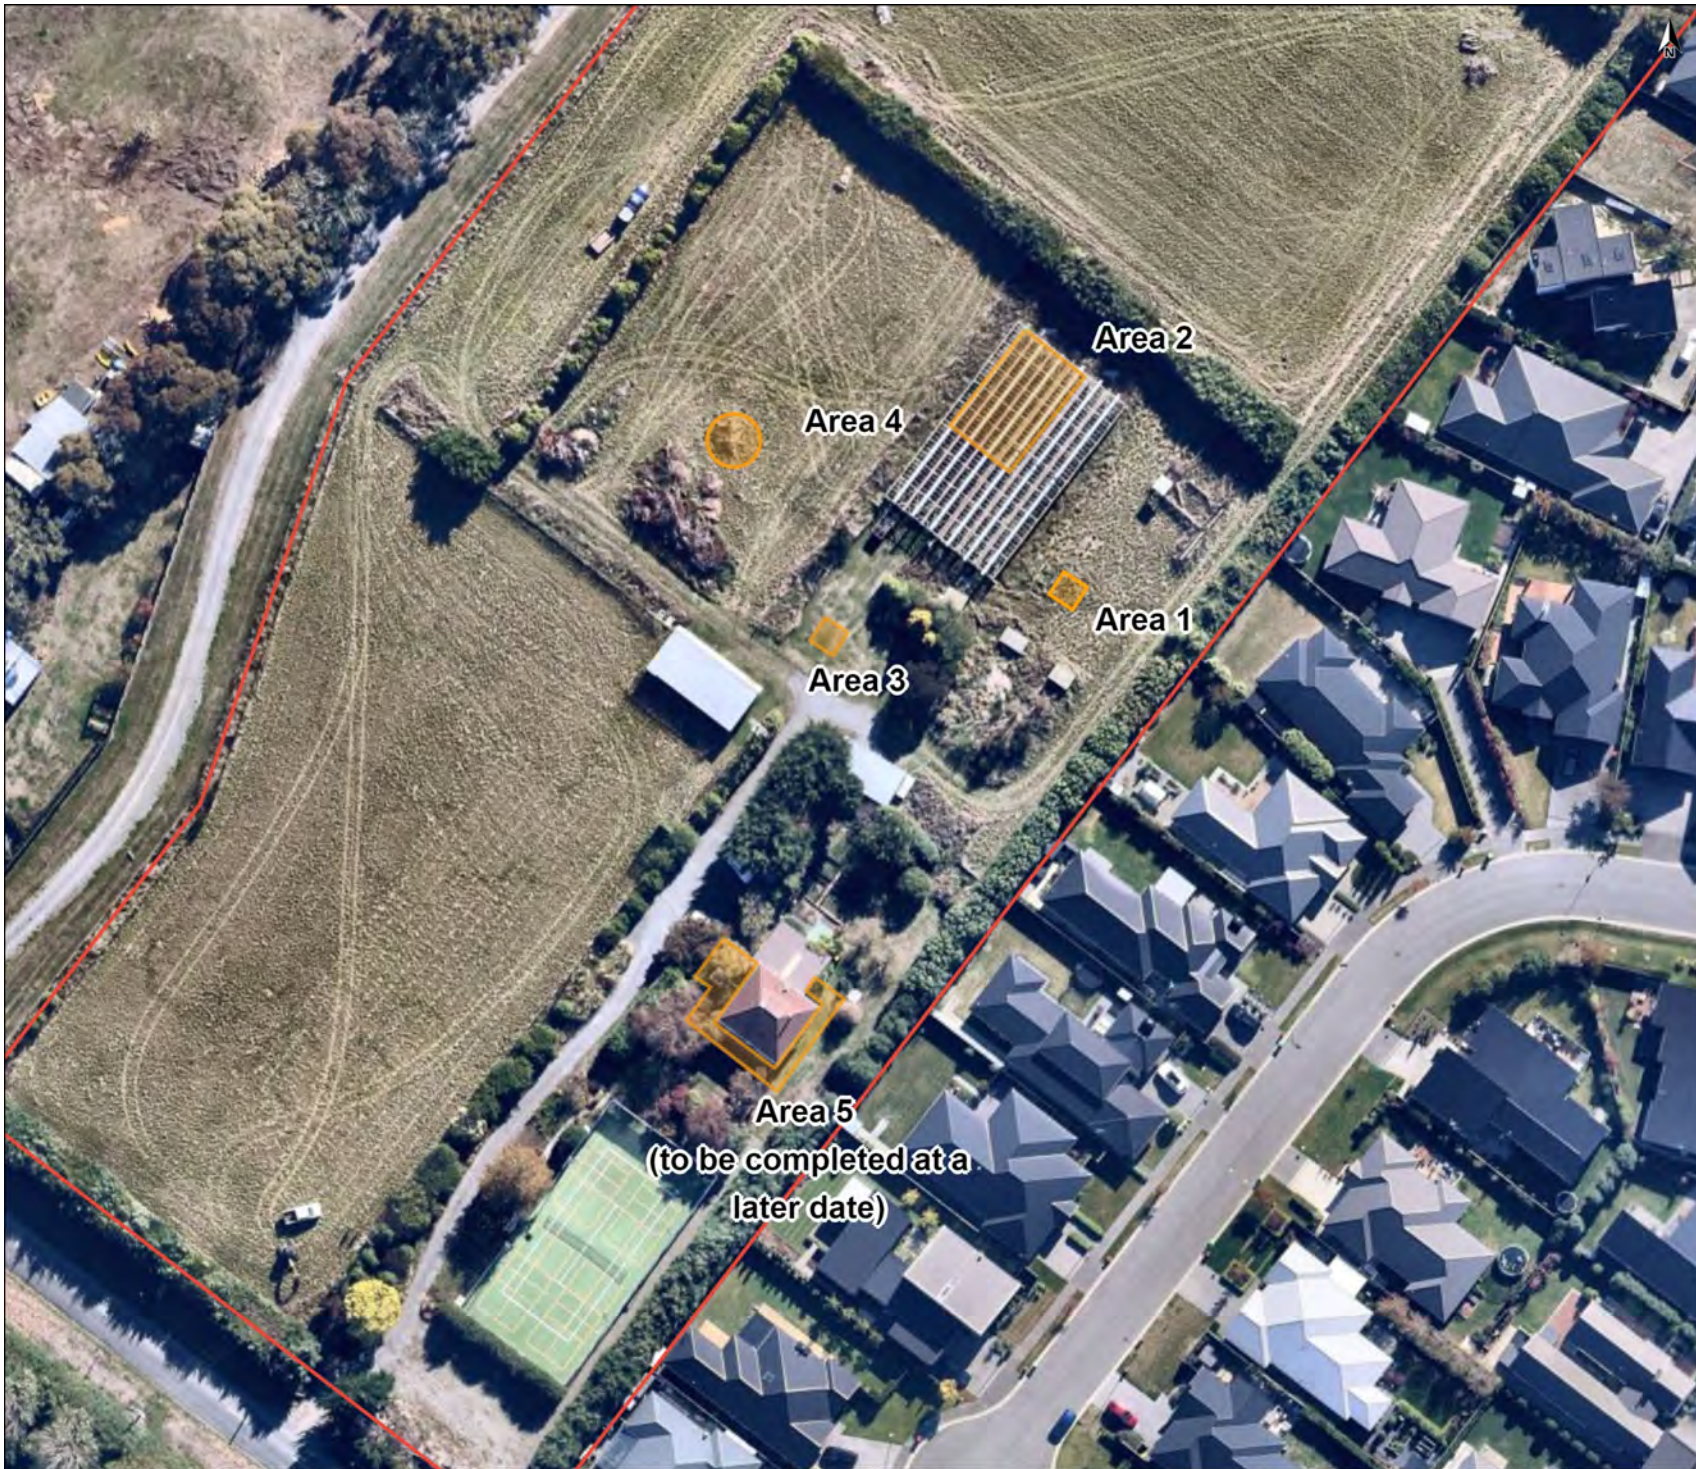
- Legend**
- Site Boundary
  - Remedial Areas

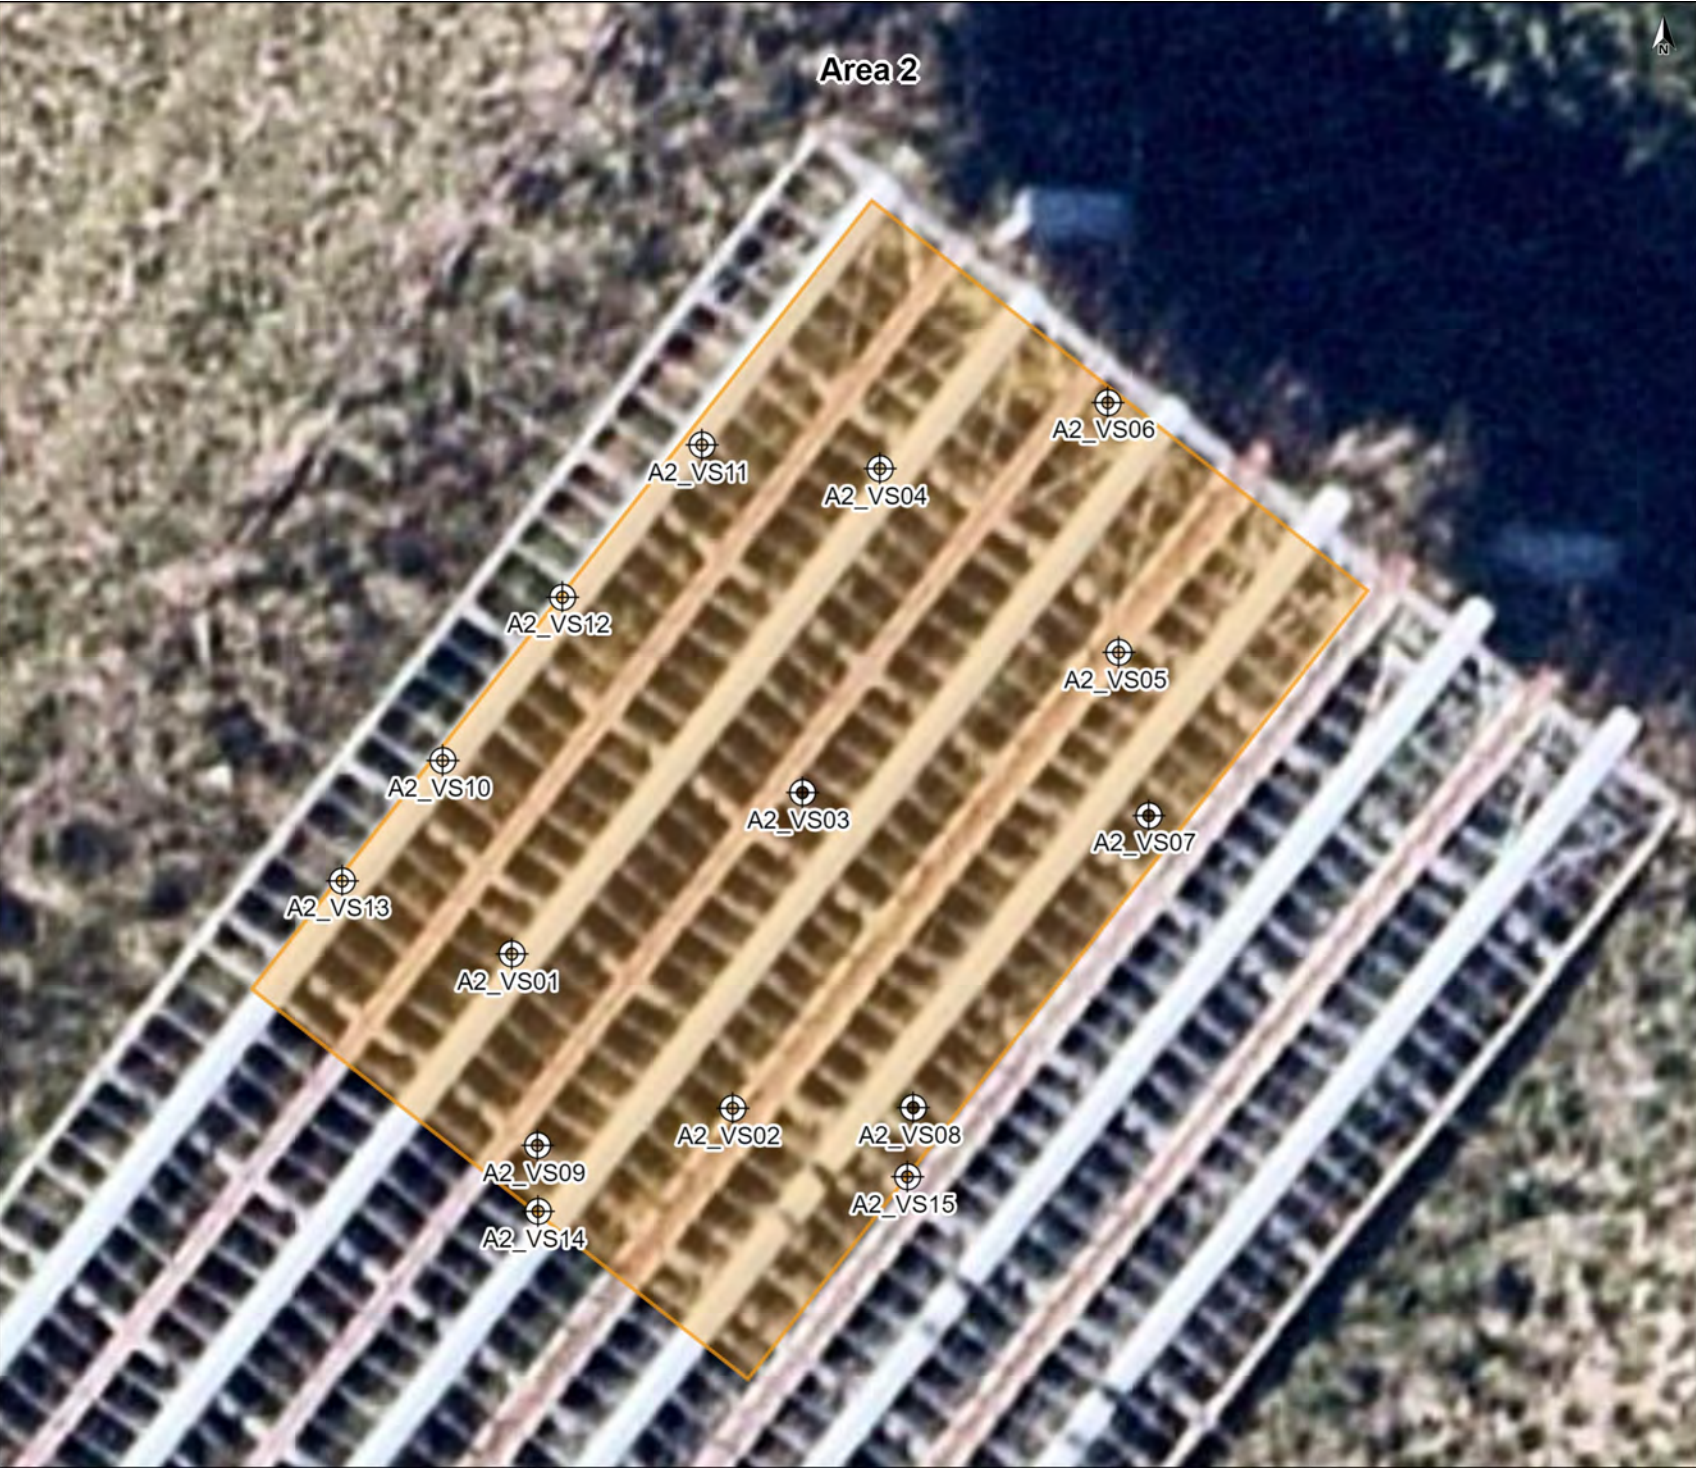
- Validation Sampling
- Remedial Areas

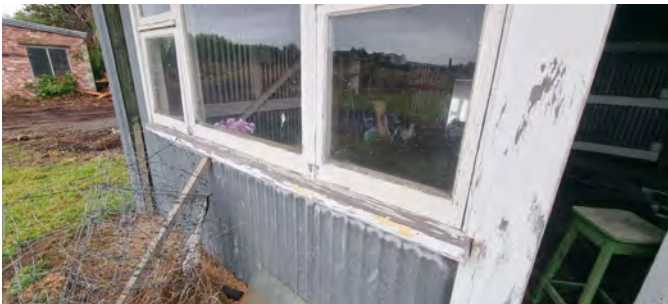
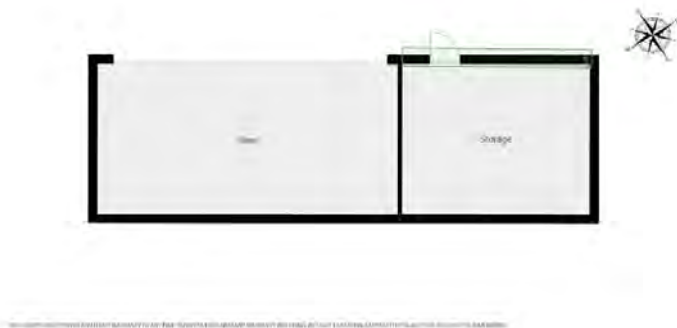
| Item | Window putty | | | | <div>Sample Location Photograph</div> |
| Product Type | Negative | | | | |
| Sample ID | 1 | | | | |
| Amount | 6 Linear metres | | | | |
| Friable? | Non-Friable | | | | |
| Risk Rating | Negative | | | 0 | |

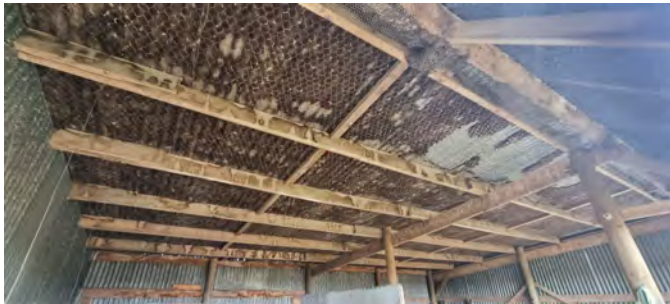
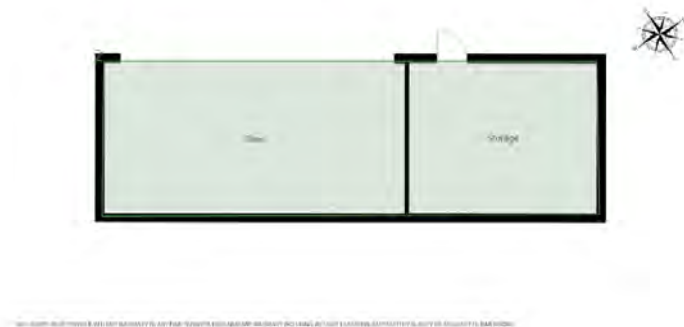
| Item | Building paper | | | | <div>Sample Location Photograph</div> |
| Product Type | Negative | | | | |
| Sample ID | 2 | | | | |
| Amount | 45 m <sup>2</sup> | | | | |
| Friable? | Friable | | | | |
| Risk Rating | Negative | | | 0 | |

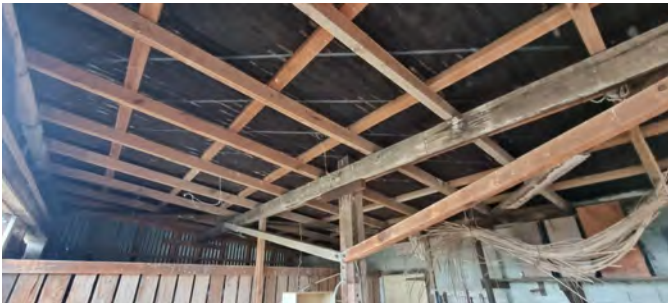
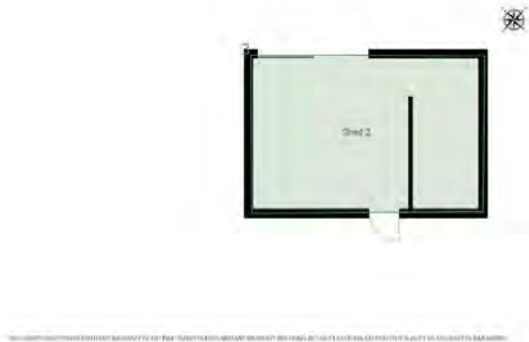
| Item | Building paper | | | | <div>Sample Location Photograph</div> |
| Product Type | Negative | | | | |
| Sample ID | 3 | | | | |
| Amount | 30 m <sup>2</sup> | | | | |
| Friable? | Friable | | | | |
| Risk Rating | Negative | | | 0 | |

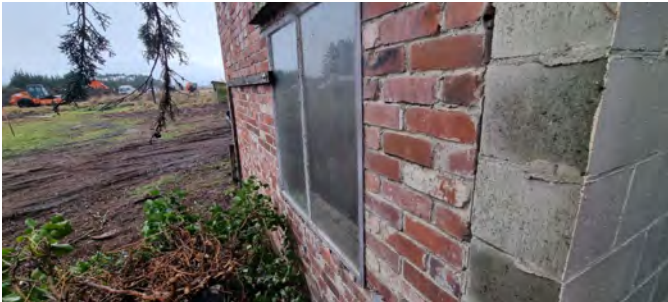
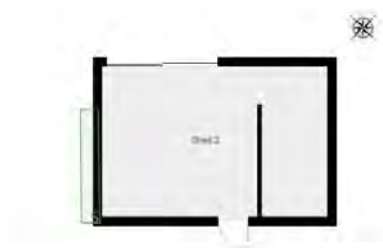
| Item | Window putty | | | | <div>Sample Location Photograph</div> |
| Product Type | Negative | | | | |
| Sample ID | 5 | | | | |
| Amount | 4 Linear metres | | | | |
| Friable? | Non-Friable | | | | |

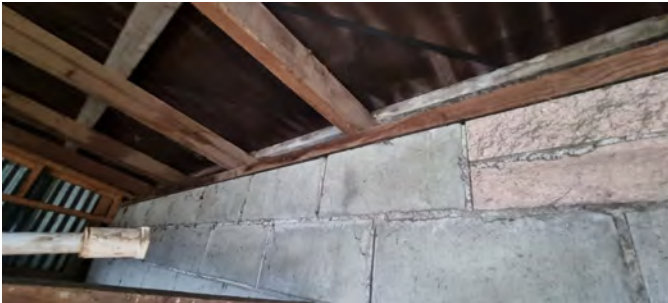
| Item | Bitumen D.P.C | | | | Sample Location Photograph | |
| Product Type | Negative | | | | | |
| Sample ID | 4 | | | | | |
| Comments | Please note: The total amount of D.P.C is unknown. The D.P.C is presumed to be present where timber framing meets concrete. | | | | | |

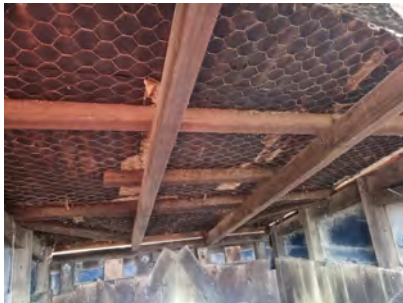
| Item | Building paper | | | | <div>Sample Location Photograph</div> |
| Product Type | Negative | | | | |
| Sample ID | 6 | | | | |

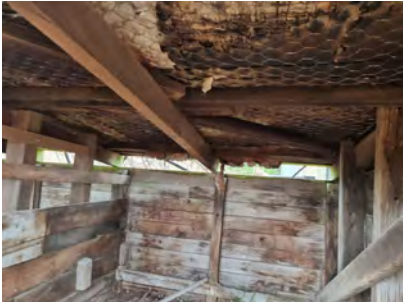
| Item | Building paper | | | | <div>Sample Location Photograph</div> |
| Product Type | Negative | | | | |
| Sample ID | AS-6 | | | | |

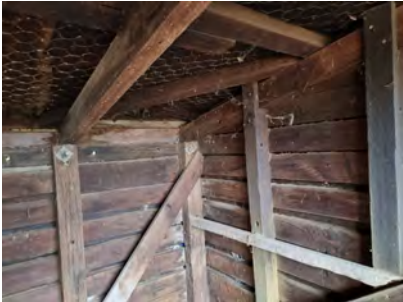
| Item | Building paper | | | | <div>Sample Location Photograph</div> |
| Product Type | Negative | | | | |
| Sample ID | AS-6 | | | | |
